PART TWO

BEACH JOB

Steven Vale reports from France on the fleet of machinery, including Euro Demolition's latest monster, at work on the cargo vessel *TK Bremen*.

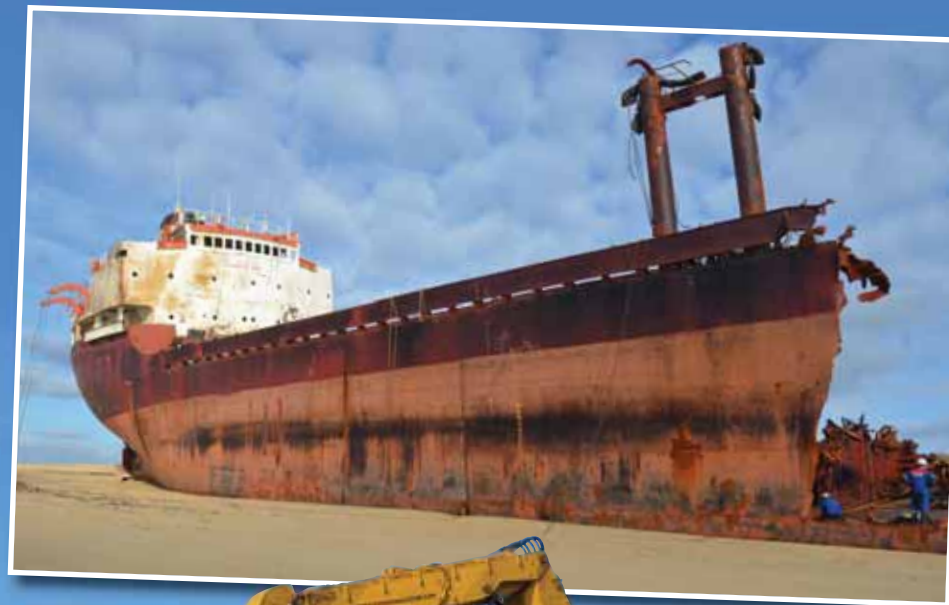
This Page: Euro Demolition won the contract to cut up the stricken cargo vessel TK Bremen. They have a month to remove the 2000-tonne structure from the beach.

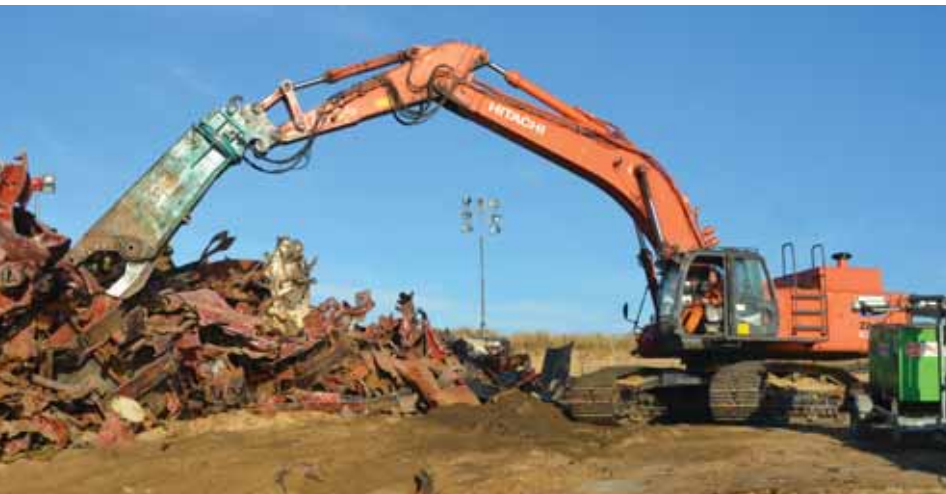
The huge metal chunks stripped from the wreckage are cut into manageable pieces by a Hitachi ZX470 with a 4.3-tonne scrap shear.

All scrap metal ripped from the wreck is piled up in front of a Hitachi ZX470 belonging to Dutch firm Scheepssloperij Nederland (Ship Demolition Netherlands). Working round the clock, the four-year-old excavator has plenty to do to keep pace, cutting the scrap into bite-size pieces. Coupled to another Dehaco-supplied scrap shear – a 4.3-tonne SH410R – a French contractor's Cat 324D loads one of the skips, which are taken off the beach by a Fendt tractor.

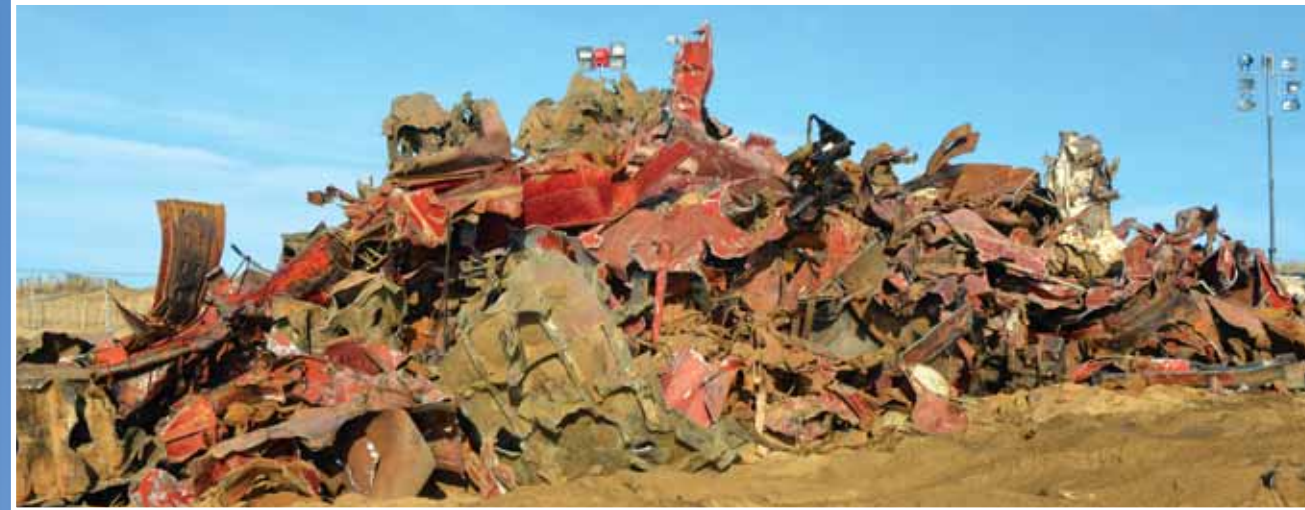
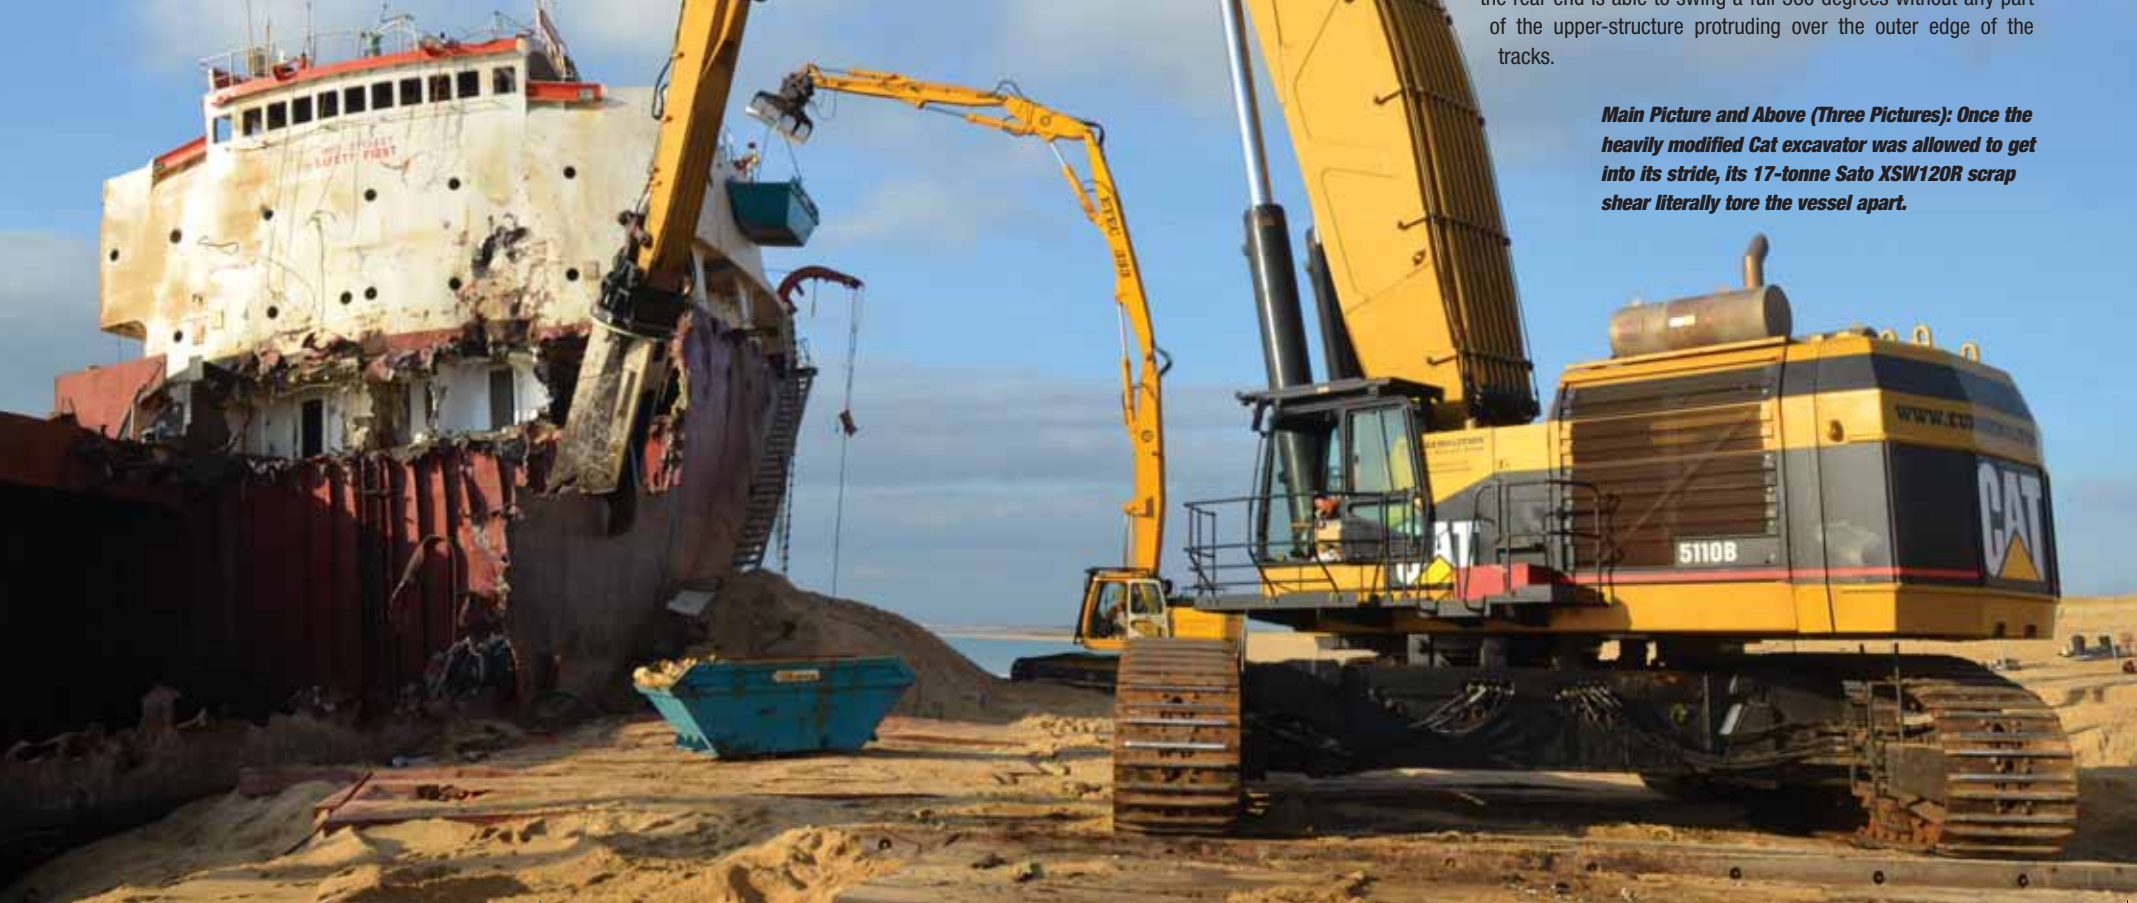
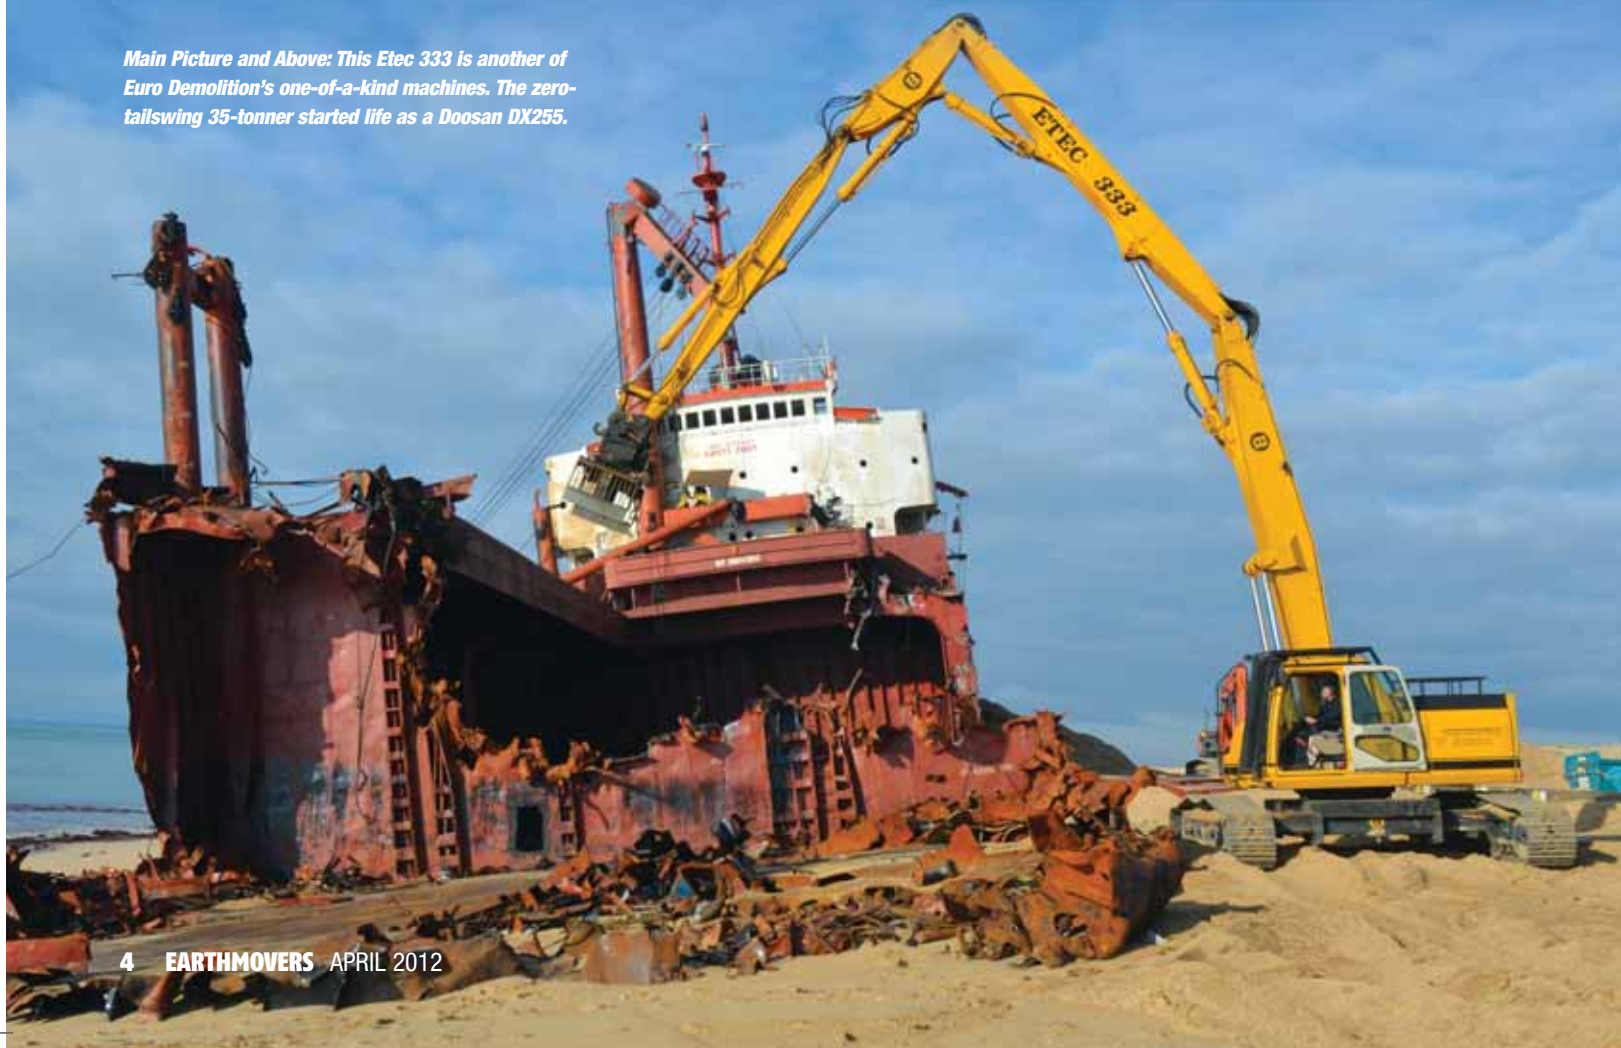
Main Picture and Above (Three Pictures): Once the heavily modified Cat excavator was allowed to get into its stride, its 17-tonne Sato XSW120R scrap shear literally tore the vessel apart.

The company's third Cat 5110B really is in a league of its own; its hefty three-piece front end carries the same attachments as its 28m sister but to the 33m mark. For this French job its weapons armoury has been bolstered with a new and equally monstrous Italian-made Sato scrap shear. Supplied by Dutch-firm Dehaco, the nearly 17-tonne XSW120R is by all accounts the first example to enter service.

Later that night the big Cat really got into its stride. The massive attachment tore huge chunks out of the structure, like a hungry vulture devouring a carcass. At the controls, Euro Demolition boss Ber Mak was clearly pushing the excavator to the limits, its rear end often just clear of the ground as he grabbed hold of another monster piece of scrap, ripping the structure apart as if it were made of paper – a truly awe-inspiring sight.

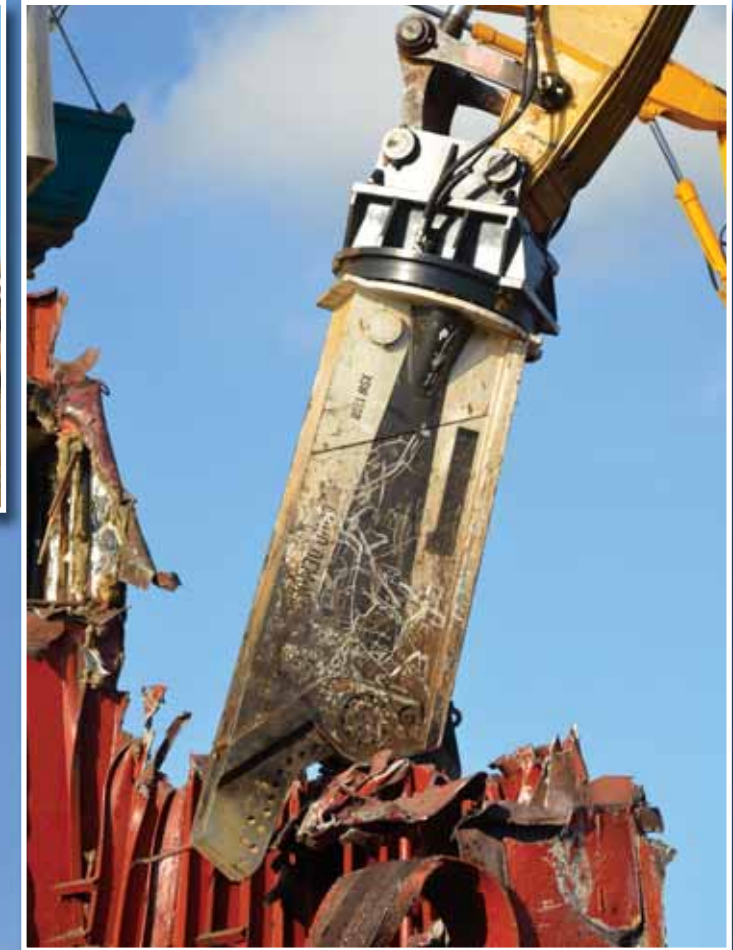
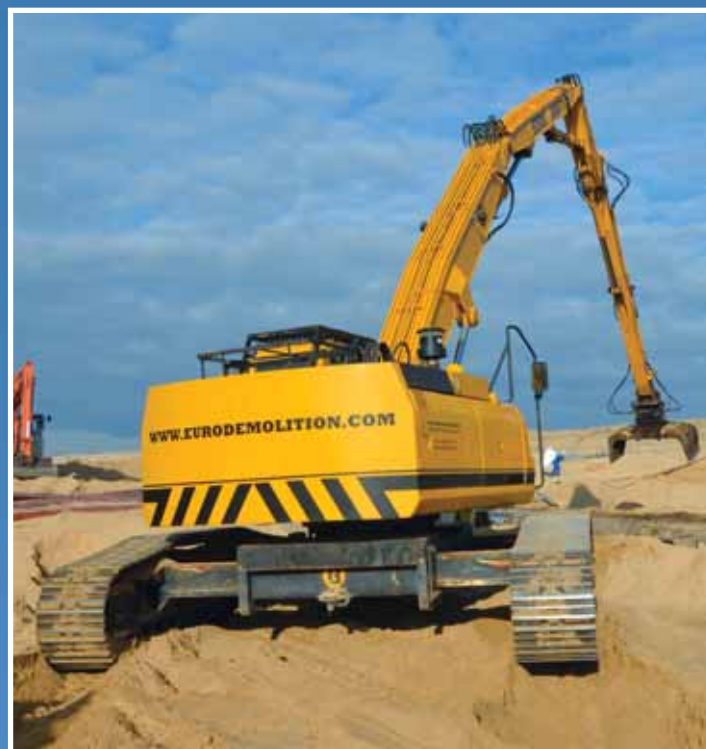
Main Picture and Above: This Etec 333 is another of Euro Demolition's one-of-a-kind machines. The zero-tailswing 35-tonner started life as a Doosan DX255.

This specially modified DX255 features a hydraulically extending undercarriage made by another Dutch specialist – Beco – and a four-piece boom. Tipping the scales at 35t, the axles extend hydraulically to an outer width of 4.2m for extra stability, while the tracks were each extended by around 1m bringing the total length to 5.2m.

An extra oil tank is mounted to the top of the upper-structure. This provides the necessary extra oil needed for the boom and hydraulically extendable tracks. Other features include a tilting cab and a narrower 6.8t counterweight to ensure that the machine remains within the tracks when slewing. Even on the maximum track width of 4.2m, the rear end is able to swing a full 360 degrees without any part of the upper-structure protruding over the outer edge of the tracks.

Fortunately, space is not an issue on the French beach, but the zero tailswing is a great feature for working in more confined areas. Weighing around 9t, the four-piece front-end equipment does not need to be removed for transport. In fact, the complete rig can be tracked on to a trailer and ready to transport within 30 minutes. On this job the excavator is ideally suited to hoisting skips up to the bridge, as it is to cleaning away the debris from the giant Cat excavator.
